Protection Home Inspection Protection Home Inspection Cincinnati, Ohio. 45245 750 Fox Creek Ln. Cincinnati, Oh 45245

1 of 31 10/15/2021 10:44 PM Prepared for: . 4684 Manorlake Dr.

Property Address 4684 Manorlake Dr. City Mason State Ohio Zip 45040 Contact Name Joseph & Emily Long Phone 513-532-2652 Fax.

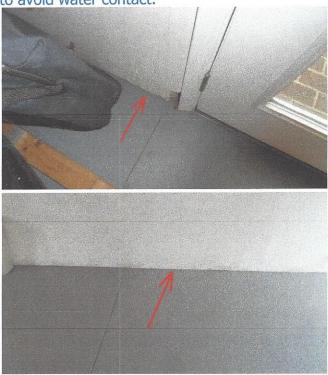
2. Side of house Garage Walls: Drywall - The drywall should be cut away from the floor 1/2 - 3/4" to avoid water contact.
